## L WATERWAY CROSSING ASSESSMENTS AND SUB-CATCHMENT DATA

### L.1 Streams with Moderate Environmental Values

## L.2 Streams with High Environmental Values

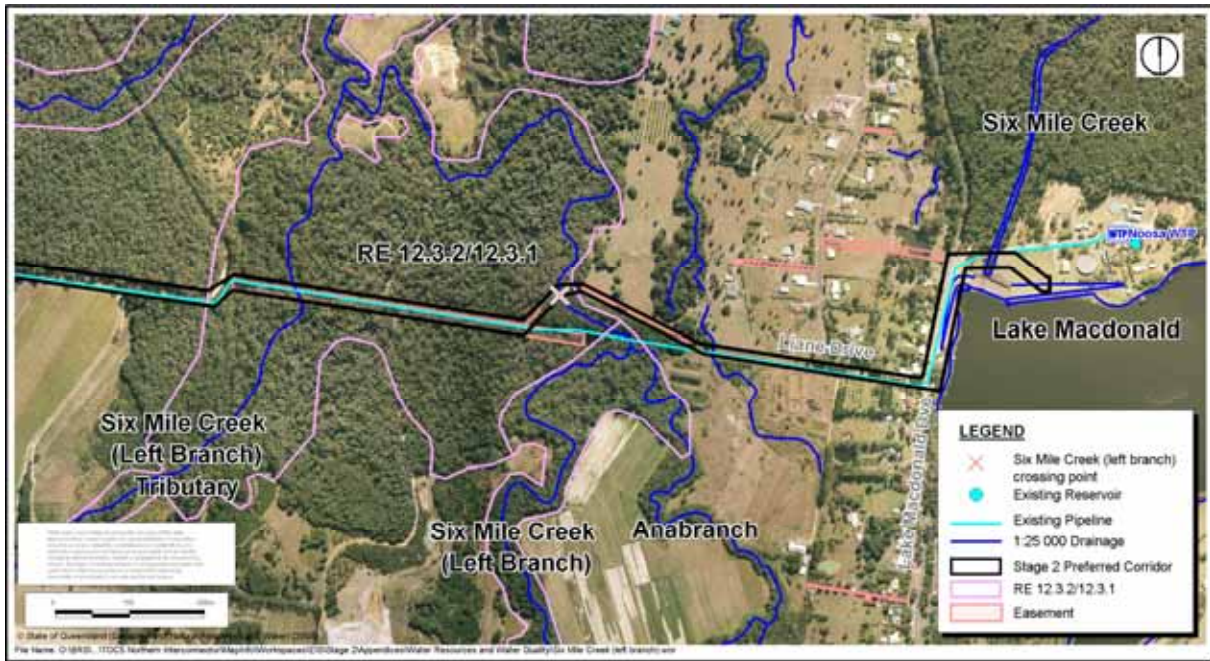
### L.2.1 Six Mile Creek (Left Branch) (Northern Crossing)

To the west of Lake MacDonald the pipeline crosses Six Mile Creek (left branch) downstream of where an anabranche rejoins the main stream. To avoid as much of the intact riparian vine forest associations (RE 12.3.2/12.3.1) in this area, the pipeline follows agricultural land and crosses where there is an existing pipeline. The pipeline can be seen in the photo below (Photo L.1). The creek crossing is 5–6 m wide and slow flowing. The riparian vegetation is RE 12.3.2/12.3.1; however, this unit is only a few metres wide on the eastern side at the crossing point. It then follows an existing easement (see Photo L.3).

This crossing point requires further and more detailed investigation to ensure sufficient information of the environmental values present in the area is gathered to enable a suitable site-specific management plan to be compiled.

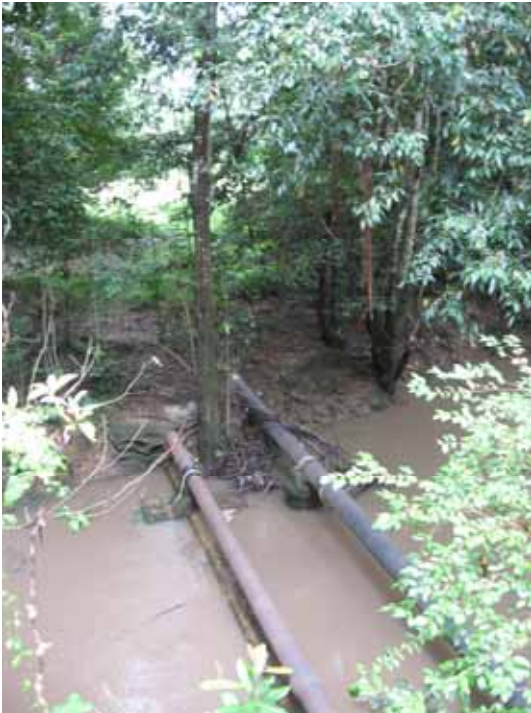
**Photo L.1**  
**PROPOSED NORTHERN CROSSING POINT AT SIX MILE CREEK (LEFT BRANCH) LOOKING EAST**

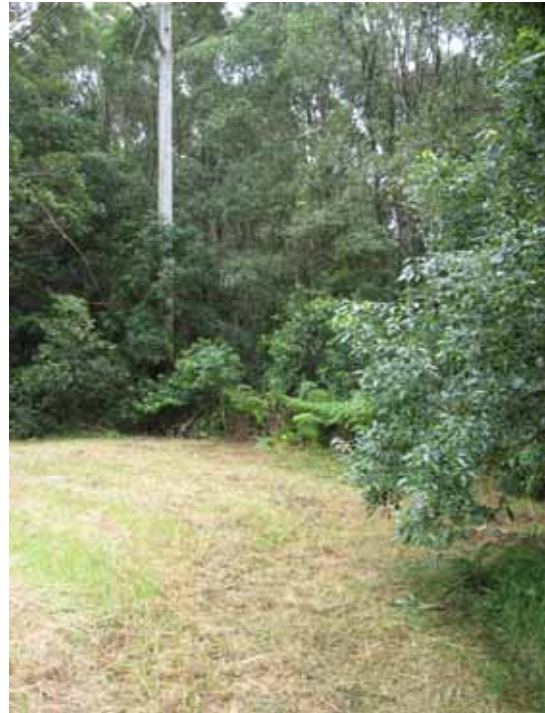
**Photo L.2**  
**VIEW TO THE WEST TOWARDS THE CROSSING POINT AT THE END OF LIANE DRIVE.**

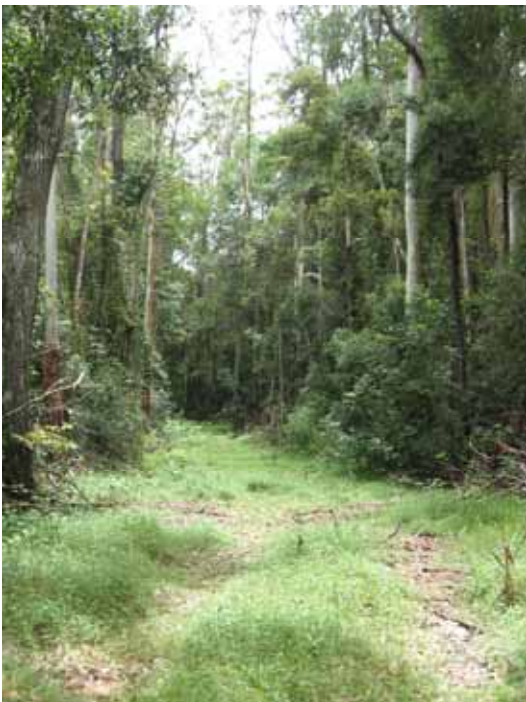
**Photo L.3**  
**EXISTING PIPELINE EASEMENT LOOKING WEST FROM SIX MILE CREEK (LEFT BRANCH)**

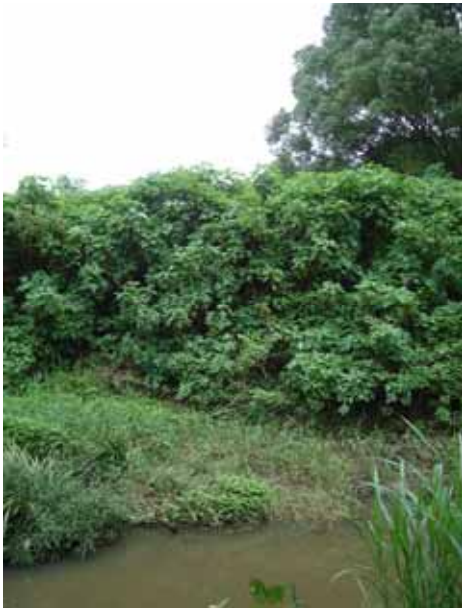
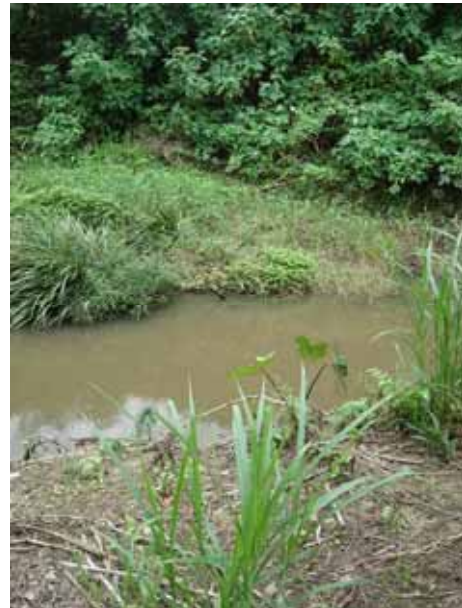
The cross-section at the crossing point is 35–40 m bank to bank, the stream is 3–5 m wide and less than half a metre deep. The south bank of Petrie Creek is relatively steep, with the initial decline broken by a terrace that gently grades into the narrow stream. The north bank has an almost 1 in 1 gradient and heavily vegetated.

The creek is a slow-flowing run with large woody debris present, as well as urban litter such as a car tyre and sheets of metal.

**Photos L.4 and L.5**  
**PETRIE CREEK LOOKING SOUTH ACROSS CROSSING POINT**

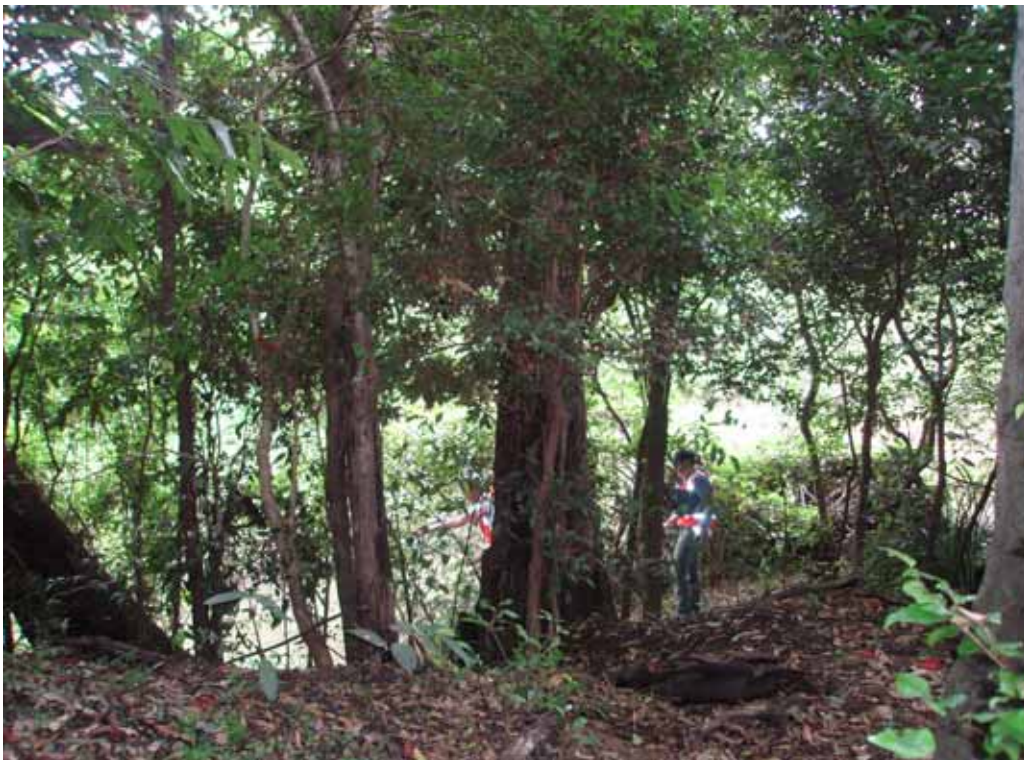
**Photo L.6**  
**NORTH BANK OF PETRIE CREEK, AT THE CROSSING POINT, LOOKING SOUTH**

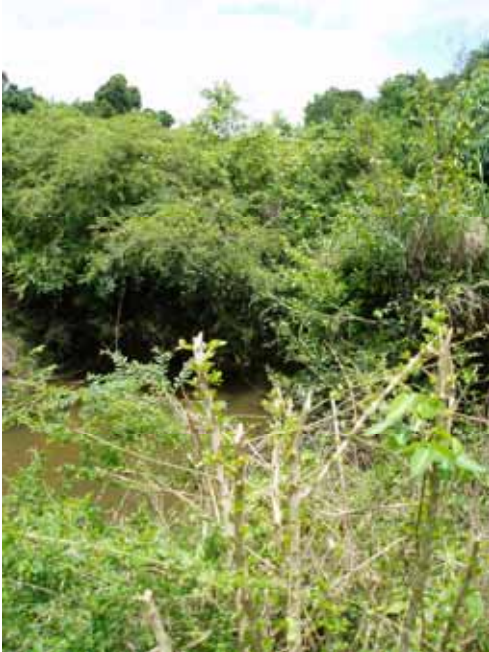
There are a number of weeds including Lantana (*Lantana camara*) present in the riparian vegetation as well as litter. Significant flora and fauna known to be present at or in close to the northern crossings include the Swamp Orchid (*Phaius tancarvilleae*) and the Tusked Frog (*Adelotus brevis*) while the Giant Barred frog (*Mixophyes iteratus*) has the potential to occur as suitable habitats are present along the creek.

**Photo L.7**  
**LOOKING NORTH ACROSS THE FOURTH CROSSING OF PAYNTER CREEK WITHIN THE EASEMENT (NOTE WEEDY REGROWTH)**

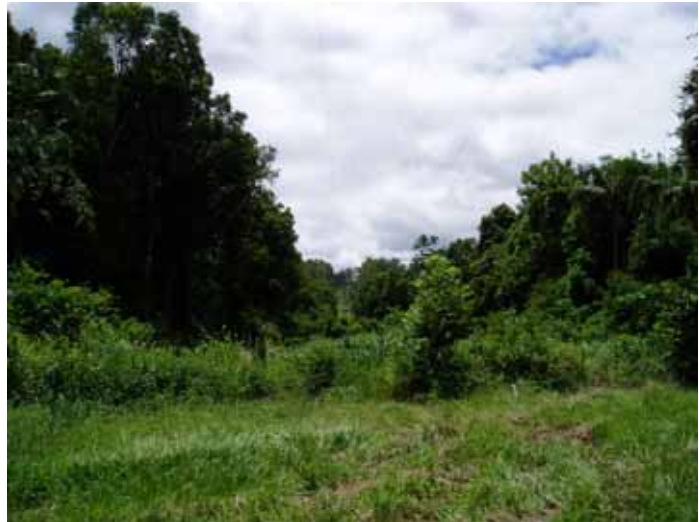
**Photo L.8**  
**LOOKING NORTH FROM THE THIRD CROSSING OF PAYNTER CREEK ALONG THE EASEMENT**
